DETERMINATION OF ELIGIBILITY NOTIFICATION

Name of property: Public School # 85

State Historic Sites Inventory Form

historic Public School 85

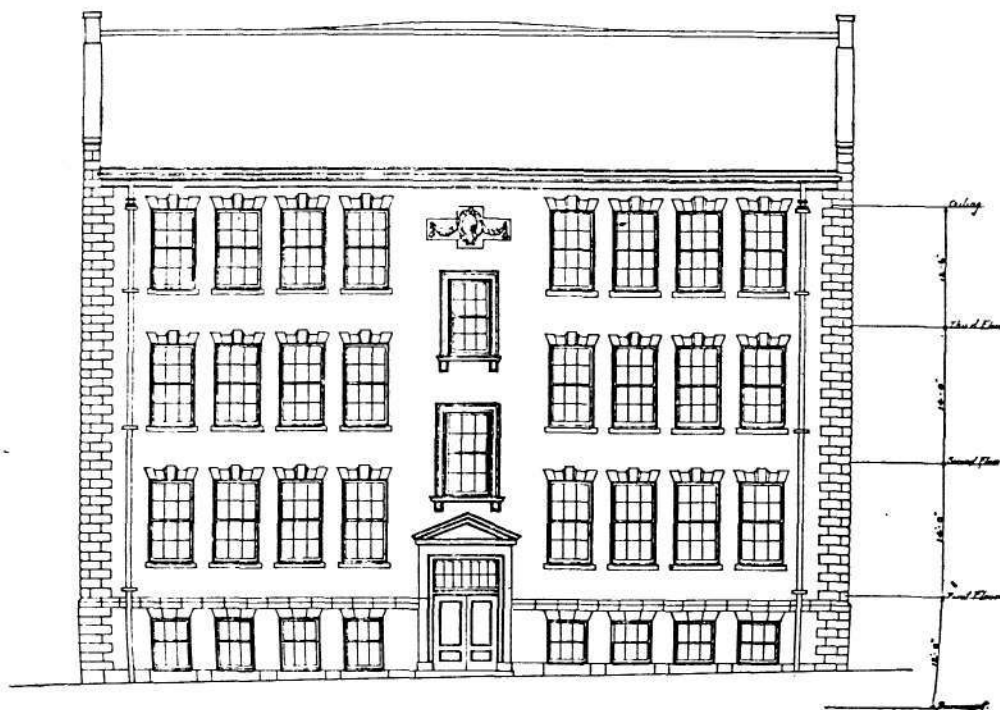
-REAR-ELEVATION-

The school building has three sections which intersect to form an "I" shaped plan. The base of the "I" is the main facade (north elevation) on the Oliver Street side of the block. The building has three stories above a raised basement. The exposed portion of the foundation is concrete. A slate-covered gabled roof covers each section of the structure. The brick walls, which are laid in Flemish bond, extend above the exterior gable-end walls forming parapets. A flat-capped exterior chimney is located at the northeast corner of the center section of the building. Two large metal vents are situated on the roof of the center section.

The identical north and south elevations are nine bays wide; the west elevation is thirteen bays wide; and the east elevation is thirteen bays wide on the second and third stories and fourteen bays wide on the first and basement stories. Only a few of the original 6/6 sash windows remain, as many of the window openings are boarded and a few basement-level openings are in-filled with masonry. The main entrances, which are centered on the north and south facades, have modern metal doors. The transom is boarded in the north entranceway, but the original wooden door frame and fourteen-pane transom remain in the south entranceway. This transom is covered with a heavy wire screen. The five entrance openings on the east elevation are boarded. Three of these doorways are located at the basement level, and two are situated in the center bays at a level midway between the basement and first story. Access from these two doorways to the schoolyard is provided by a concrete stoop and two concrete stairways.
